Manhole Inspection Summary

Manhole # S49M__013MH

Insp Date: **4/16/08 2:09 PM**

Location Address: **2500 hudson st**

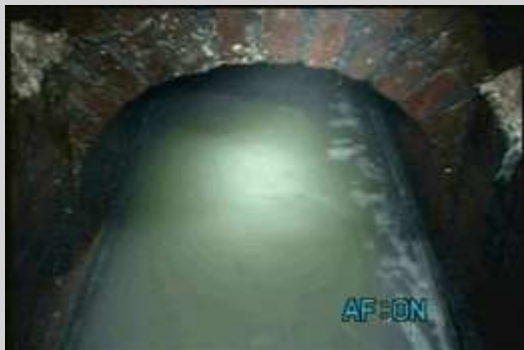
12 O'Clock Outflow

27 in. Circular Gravity Sewer
Pipe Out @ 12 O'Clock

Pipe Material: **Clay** ☐ Pipe Lined

Invert Depth: **13.41** (ft.) Flow Characteristics: **Fast**

Deposits: ☒ None ☐ Mud ☐ Sludge ☐ Debris ☐ Grease

Infiltration: **None** Pipe Seal Cond: **Unknown**

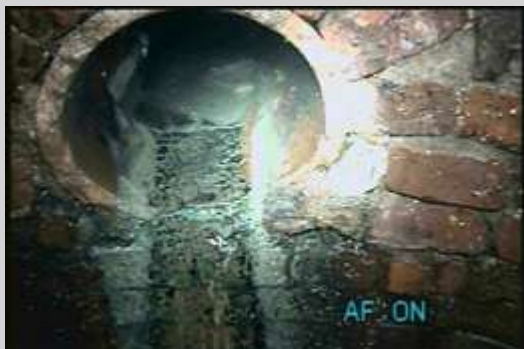
3 O'Clock Inflow

8 in. Circular Gravity Sewer
Pipe In @ 3 O'Clock

Pipe Material: **Clay** ☐ Pipe Lined

Invert Depth: **7.66** (ft.) Flow Characteristics: **Fast**

Deposits: ☒ None ☐ Mud ☐ Sludge ☐ Debris ☐ Grease

Infiltration: **None** Pipe Seal Cond: **Unknown**

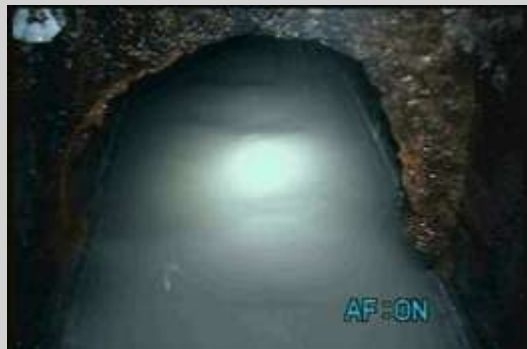
6 O'Clock Inflow

27 in. Circular Gravity Sewer
Pipe In @ 6 O'Clock

Pipe Material: **Clay** ☐ Pipe Lined

Infiltration: **None** Pipe Seal Cond: **Unknown**
